SUBJECT: US-2, CS 0403, MP 103.8 to 104.8, XL – 2072

Peshastin East - Interchange

Geotechnical Report

## **Peshastin East Interchange**

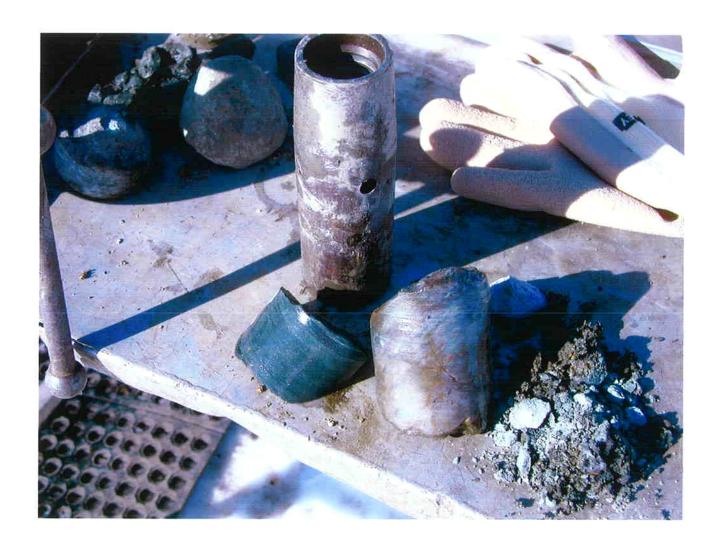
Figure C.1: Gravel and Cobbles
Boring: H-1-04

Depth: 15 ft

is present. The presence of cobble and boulder size material in the gravel layer is evidenced by the material recovered during coring (see images in Appendix C), the test pit excavation and by the behavior of the drill. Additionally, the presence of the cobbles and boulders in the gravel layer is consistent with the glacial deposition environment of the material. In order to obtain representative grain size distributions and a qualitative estimate of the difficulty expected during excavations for roadway cuts and/or structure foundations, we excavated the test pit described above. Bulk samples of the material from the test pit were collected and grain size distributions determined.

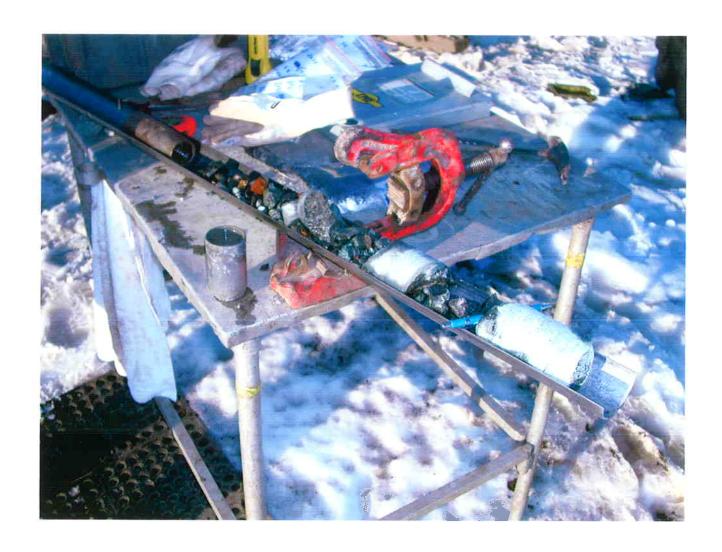
Figure C.2: Gravel and Cobbles
Boring: H-1-04
Depth: 25 ft

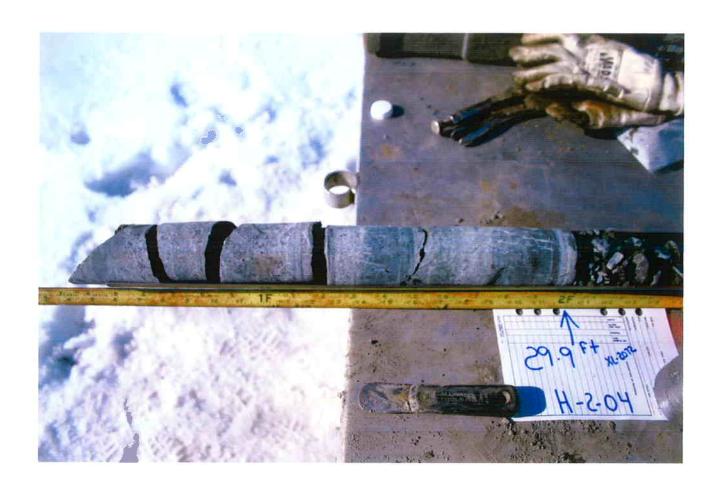
Figure C.3: Boulder Boring: H-2-04 Depth: 29.9 ft

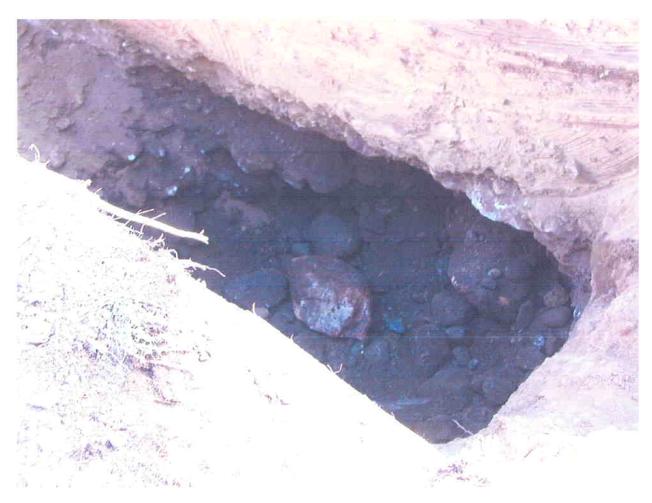
Figure C.4: Test Pit Excavation
Test Pit: TP-1-04
Depth: 0-8 ft

The test pit was conducted to provide direct visual observation of the consistency and grain size of the material into which the cuts will be made, and to correlate the near surface soils observed in the test borings. Representative bulk soil samples were collected from the test pit. Images of the excavated test pit is shown in Appendix C.

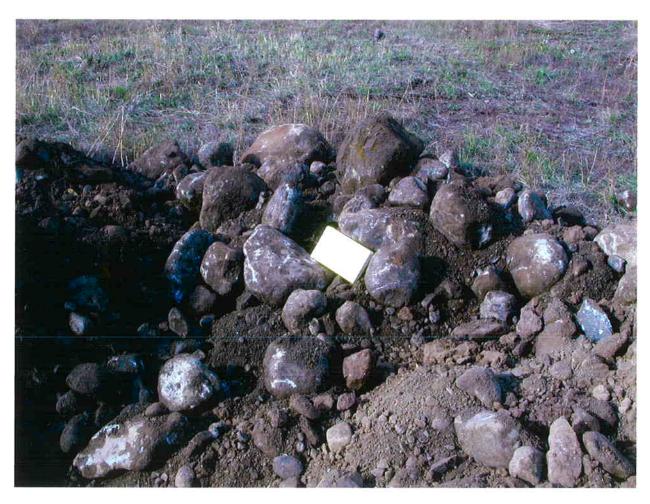
Figure C.5: Cobbles and Boulders Excavated From Test Pit
Test Pit: TP-1-04
Depth: 0-8 ft

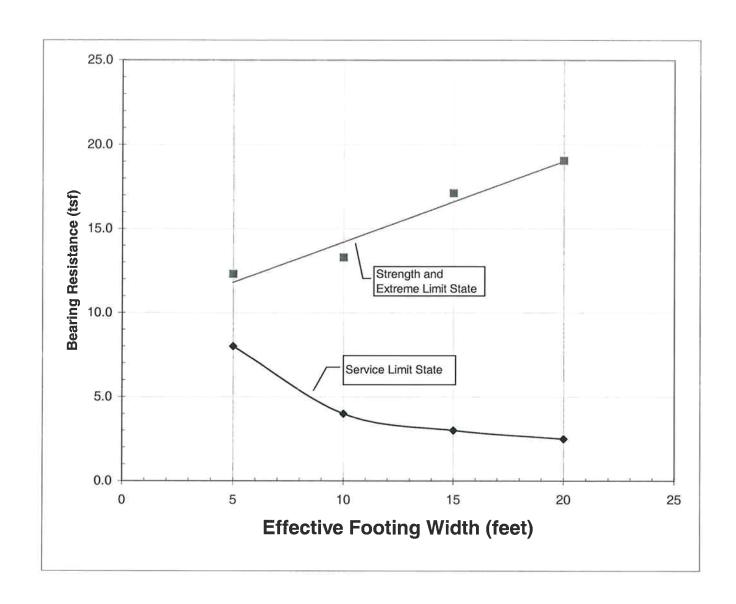
# Nominal Bearing Resistance vs Footing Width US-2/US-97 Bridge Abutment Piers 1 and 2

The conditions observed at the planned bridge abutment locations indicate the area is underlain by very dense poorly graded gravel with varying amounts of sand, cobbles and boulders. A chart of recommended bearing resistance versus footing width is presented in Appendix D for Service, Strength, and Extreme Limit loading states. The Service Limit State curve is for footing resistance that corresponds to 1 inch of settlement. The minimum embedment depth of the footings should be at an elevation of about 1074 feet, and should also meet minimum embedment requirements in the BDM for footings.

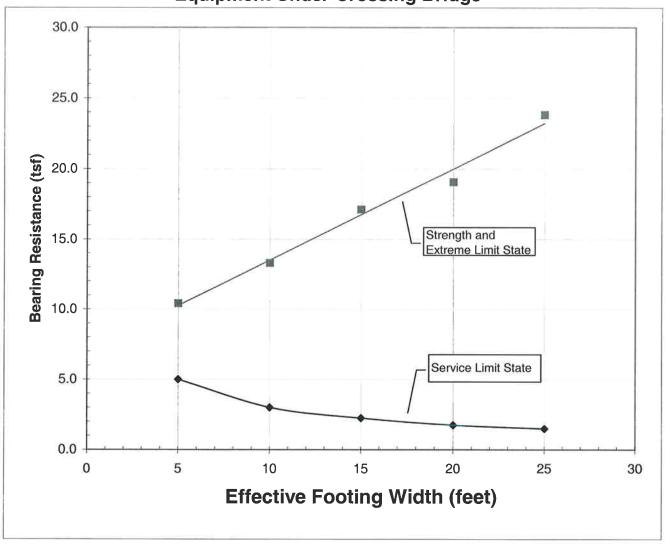
# Nominal Bearing Resistance vs Footing Width Equipment Under-Crossing Bridge

The conditions observed at the planned equipment crossing bridge abutment locations indicate the area is underlain by very dense poorly graded gravel with varying amounts of silt, sand, cobbles and boulders and dense to very dense silty sand. A chart of recommended bearing resistance versus footing width is presented in Appendix D for Service, Strength, and Extreme Limit loading states. The Service Limit State curve is for footing resistance that corresponds to 1 inch of settlement. The minimum embedment depth of the footings should be at an elevation of about 1072 feet, and should also meet minimum embedment requirements in the BDM for footings.
